# Built for Ride: A Case Study in Improving Ride Quality on SH 130

Omar X. De Leon, P.E. – Austin District  
Gisel Carrasco, P.E. – Materials & Tests Division

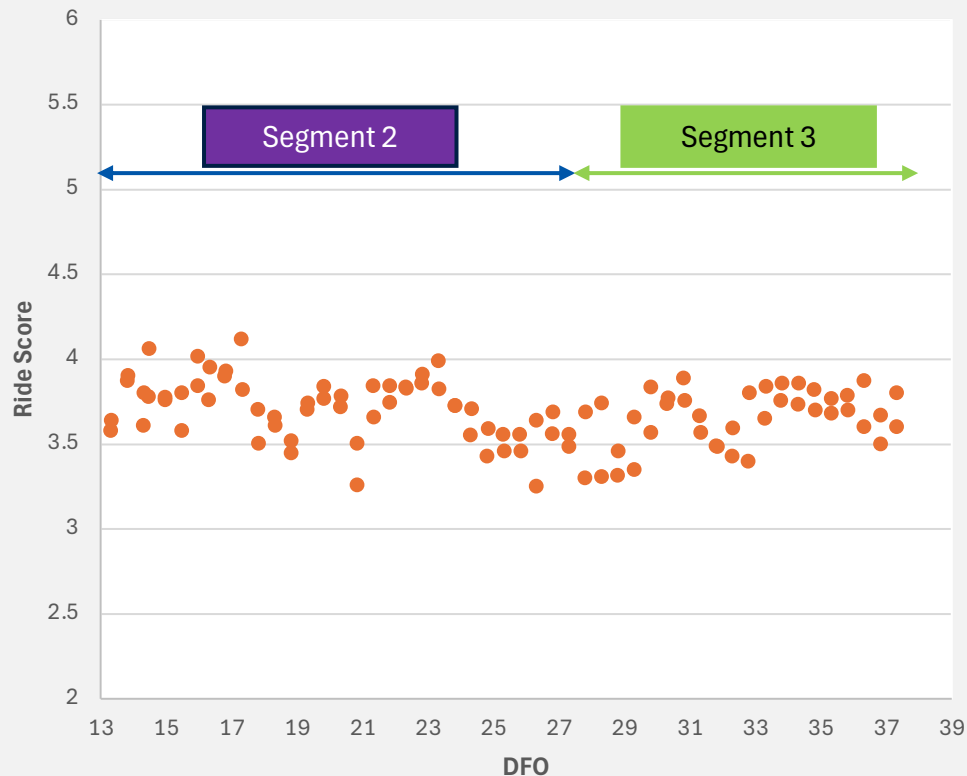
## Ride Score Data

- Existing ride and distress was so bad it impacted our ride
- Ride score prior to project ranged between 3.3-4.1
- 5.0 is a perfect ride

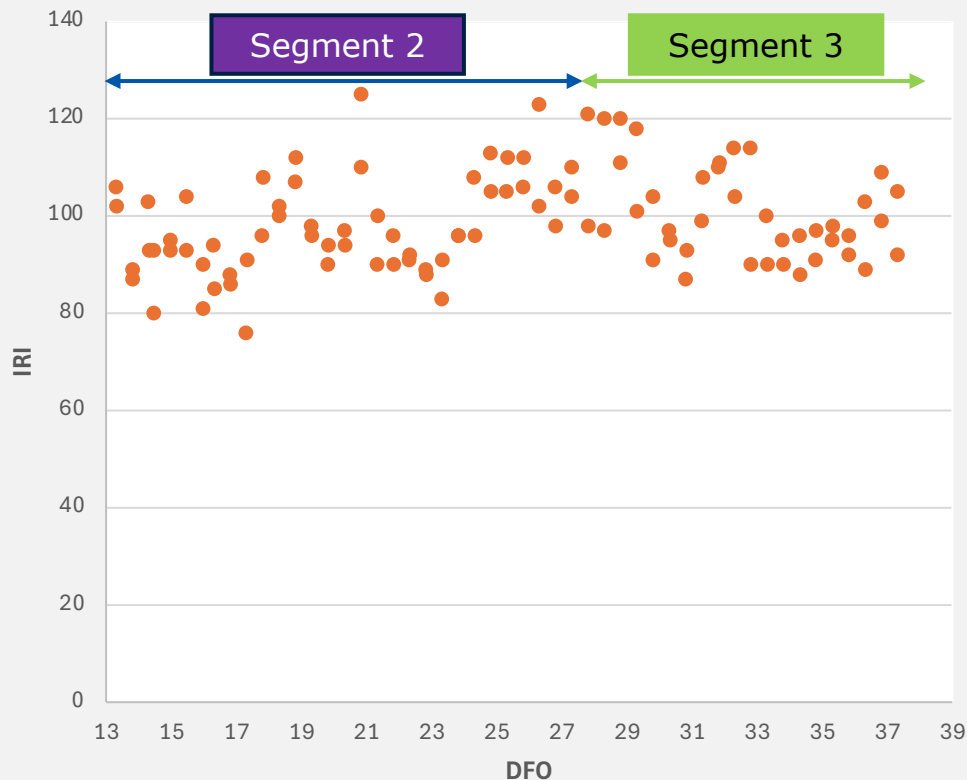
## IRI Data

- IRI prior to project ranged between 76-125
- The smaller the number the better
- In the “Danger Zone” of ride

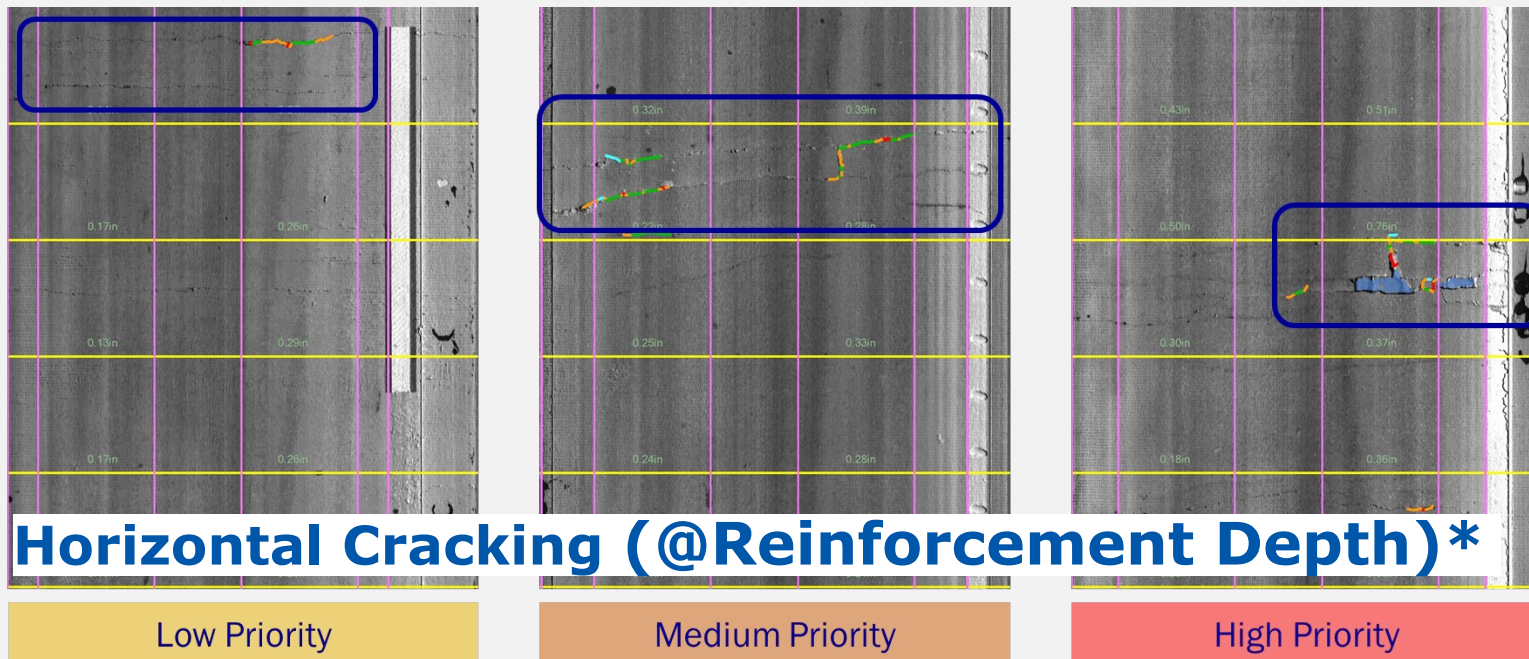
## Automated Cracking and Surface Distress

\*Distress due to horizontal cracking at reinforcement depth is not included in the Rater's Manual, high priority is based on rated spalled crack and punchout.

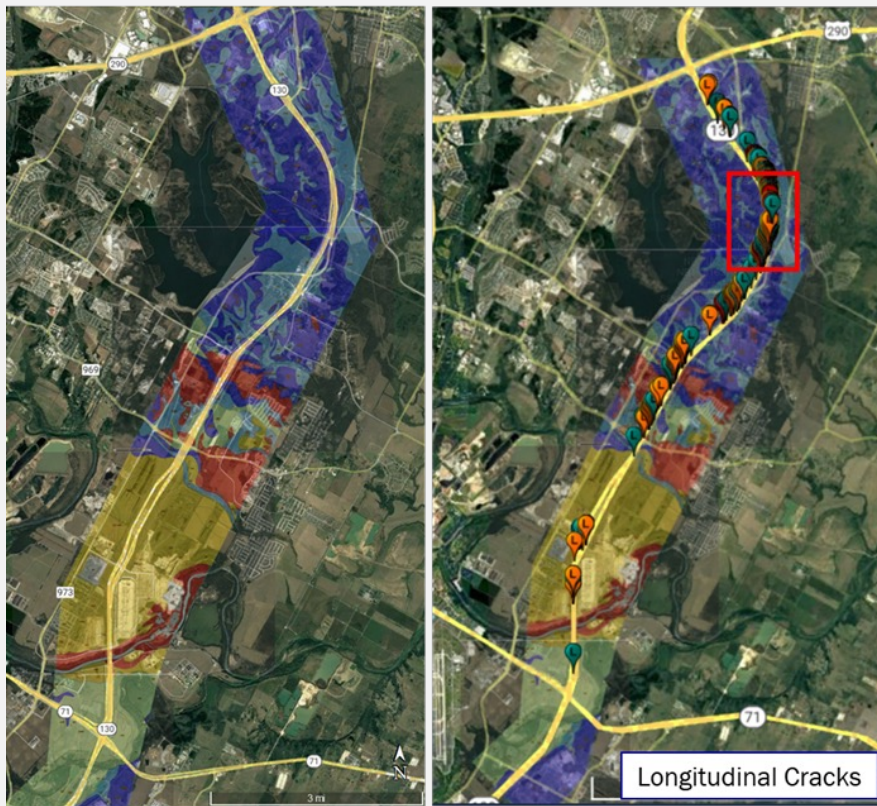
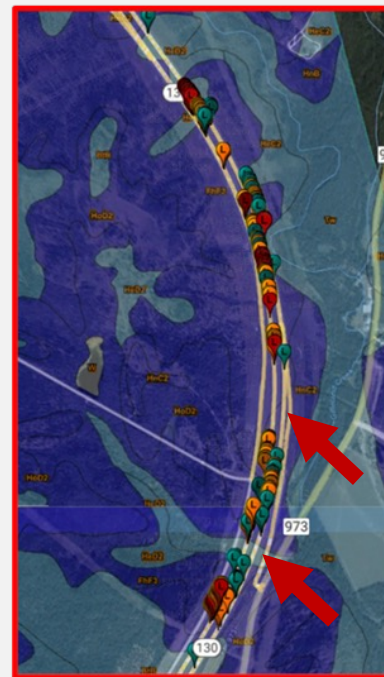
# Web Soil Survey

Plasticity Index –  
Longitudinal  
Cracking Correlation

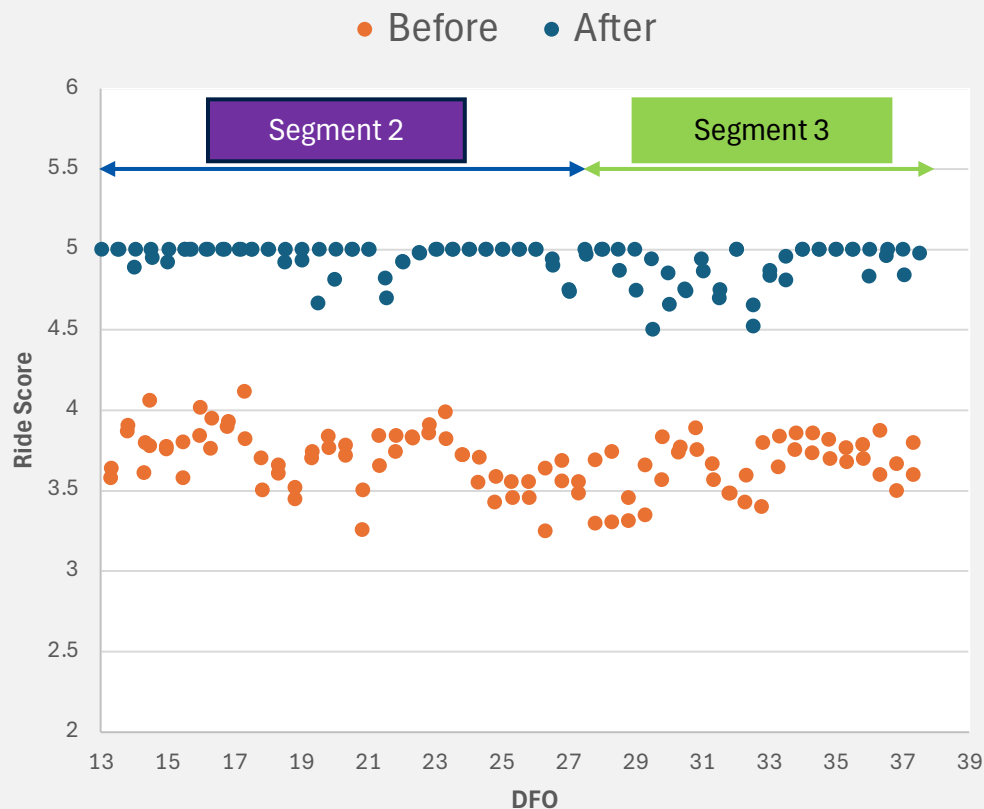
## Ride Score after overlays

- Prior to project ranged between 3.3-4.1
- After project 4.5-5.0

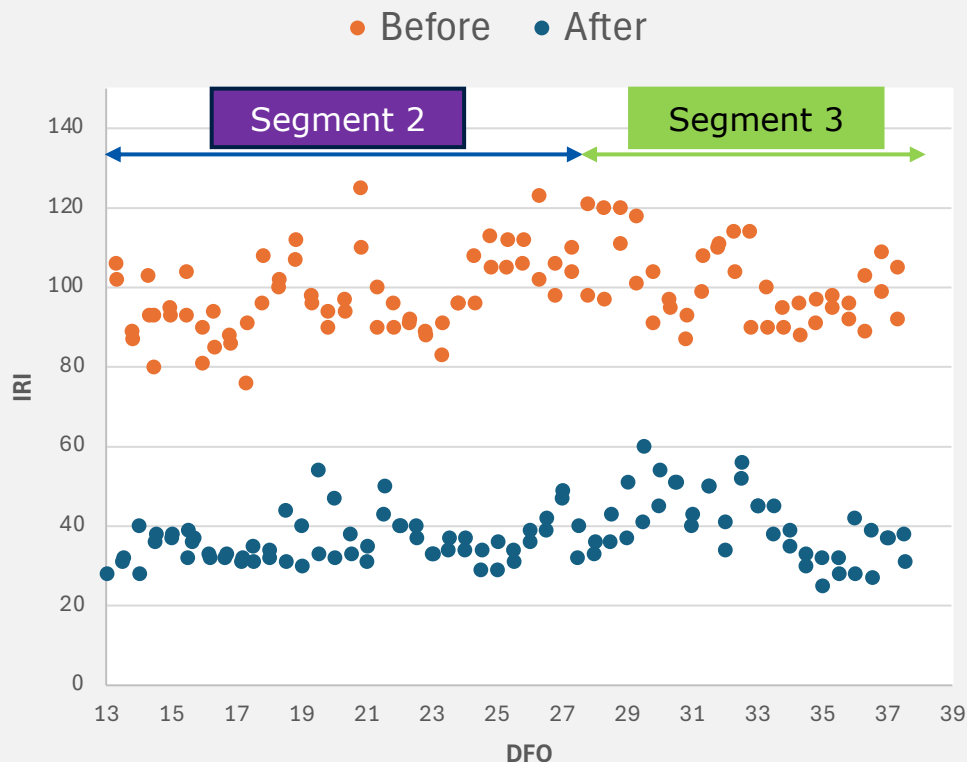
## IRI after overlays

- IRI prior to project ranged between 76-125
- After project 25-60

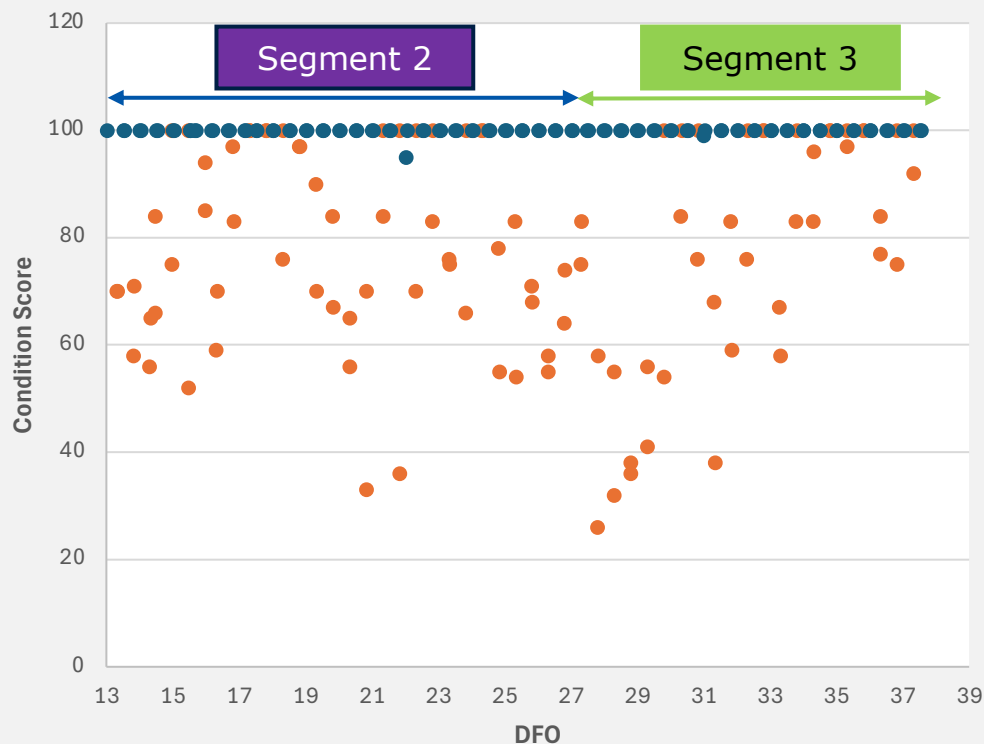
## Roadway Condition Score Data

- Prior to project ranged between 28 and 100
- After project was 100
