# Built for Ride: A Case Study in Improving Ride Quality on SH 130

Omar X. De Leon, P.E. – Austin District  
Gisel Carrasco, P.E. – Materials & Tests Division

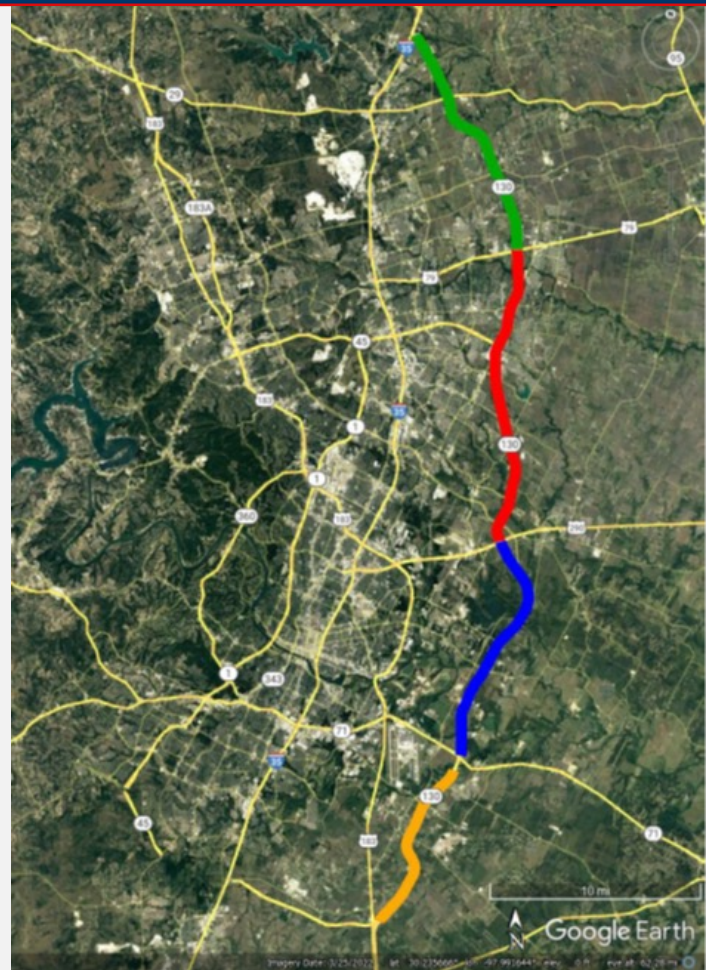
# The 20-Year Mark SH 130

*Celebrating with a  
Rough Ride*

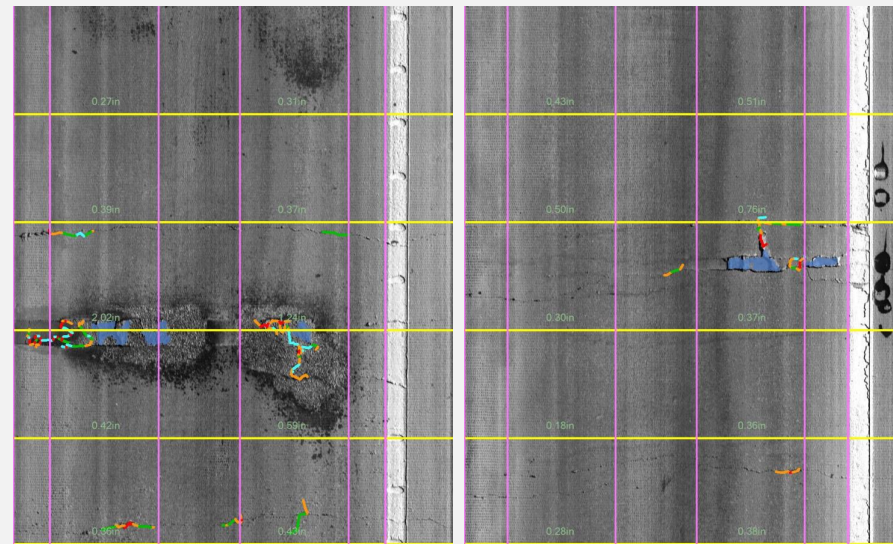
## Key issues on the Corridor

- **Increasing development & ADT on corridor**
- **Construction on IH 35 had commenced**
- **Speed Limit 80 MPH**
- **Many distress types**
  - Spalling from previous repairs
  - Cracking
  - Failures
- **Many complaints/concerns regarding safety**
- **All on the "2<sup>nd</sup>" Interstate in the Austin District**
